Iowa Department of Cultural Affairs
State Historical Society of Iowa
Iowa Site Inventory Form
Continuation Sheet

Name of Property _____ G.F. Knostman & Son Building _____ County _____ Scott _____

Address _____ 207 (207-209) E. 2nd Street _____ City _____ Davenport _____

SITE DESCRIPTION

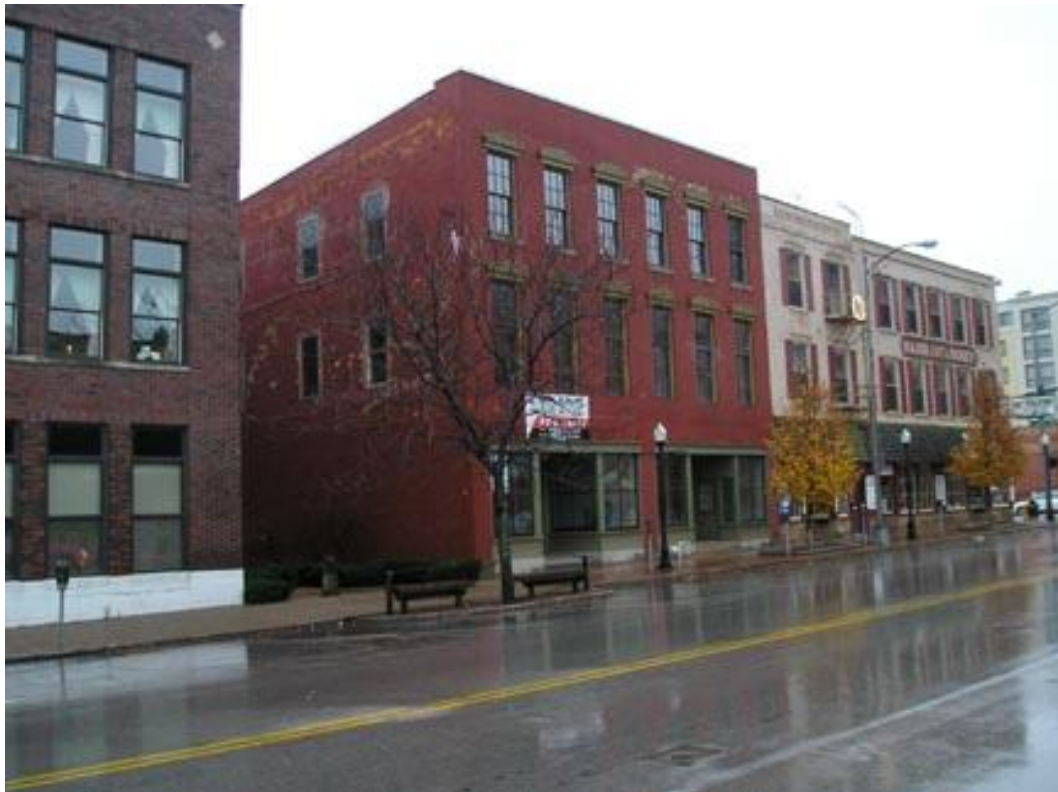
Windows dominate the upper stories of this structure. Both floors feature six, double-hung windows per floor, set into the wall plane at even intervals. The window lights of the second floor are arranged in a 6/9 configuration. The lights of the third floor arranged in a 6/6 configuration. Each window features a heavily ornate hood; delicately arched and deeply carved. The windows appear to be original. Certainly, the openings are intact and the original light configuration retained.

As a masonry structure, the greatest concern for this building is the condition of its brick. A visual inspection from street level reveals joint loss and evidence of spalling across the face of the upper stories. This condition is somewhat disguised by the application of paint, but nonetheless detrimental to the masonry.

View of the primary (north) elevation, looking southwest across E. 2nd Street.

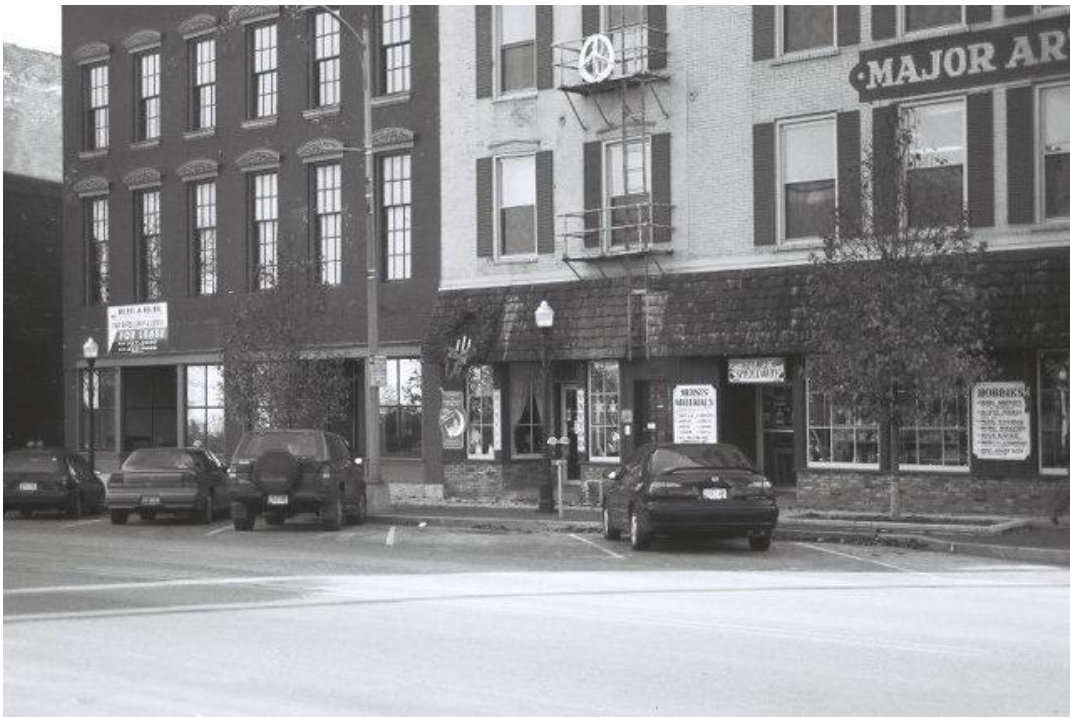
The secondary (east) elevation has large areas of significant spalling and joint loss. This condition is common to structures that lose an adjoining building with a common wall. The windows of this wall have been retrofitted.

View of the Knostman building, looking southeast across E. 2nd Street.

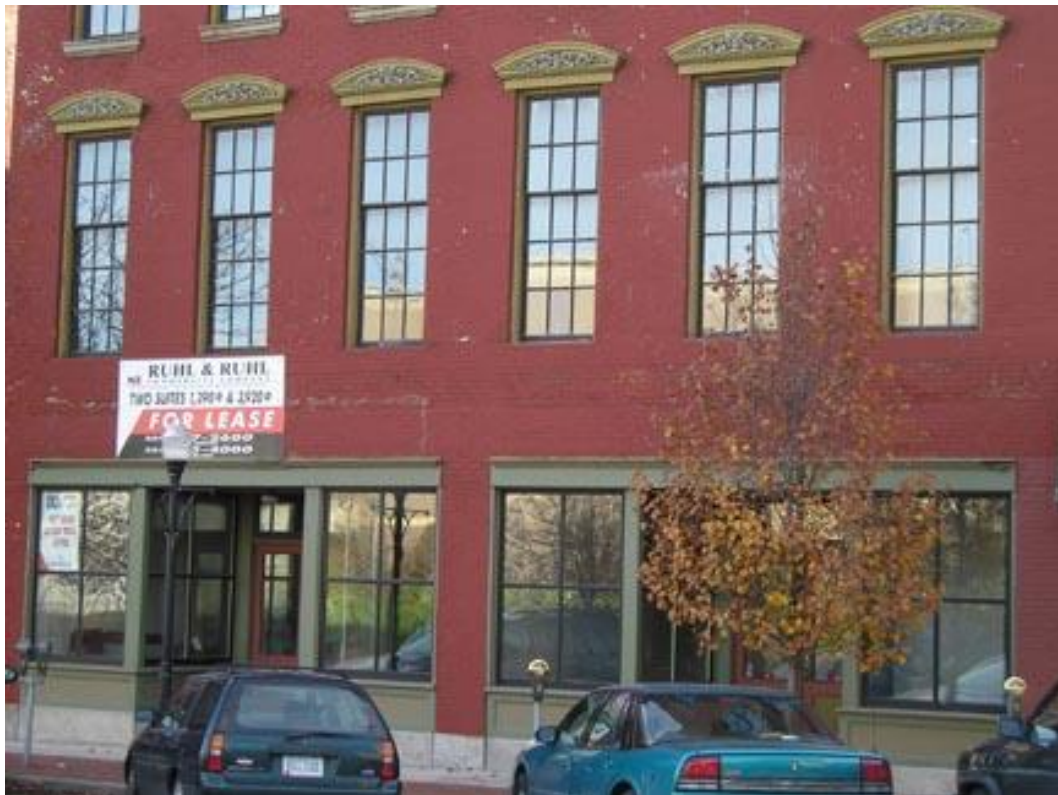
Also typical of commercial structures, the façade is broken into three basic parts: the storefront, the upper wall and the cornice. In this building, the historic storefront is has been recently restored; a comparison to a historic images indicates the rehabilitation is quite accurate although some change to the transom area has been made. It should be said that the condition of the storefront at the time of the rehabilitation is unknown; meaning, the original storefront may have been intact and repaired rather than reconstructed.

Detail view of the storefronts and first story fenestration. Note that the window configuration remains intact, as do the ornate window hoods.

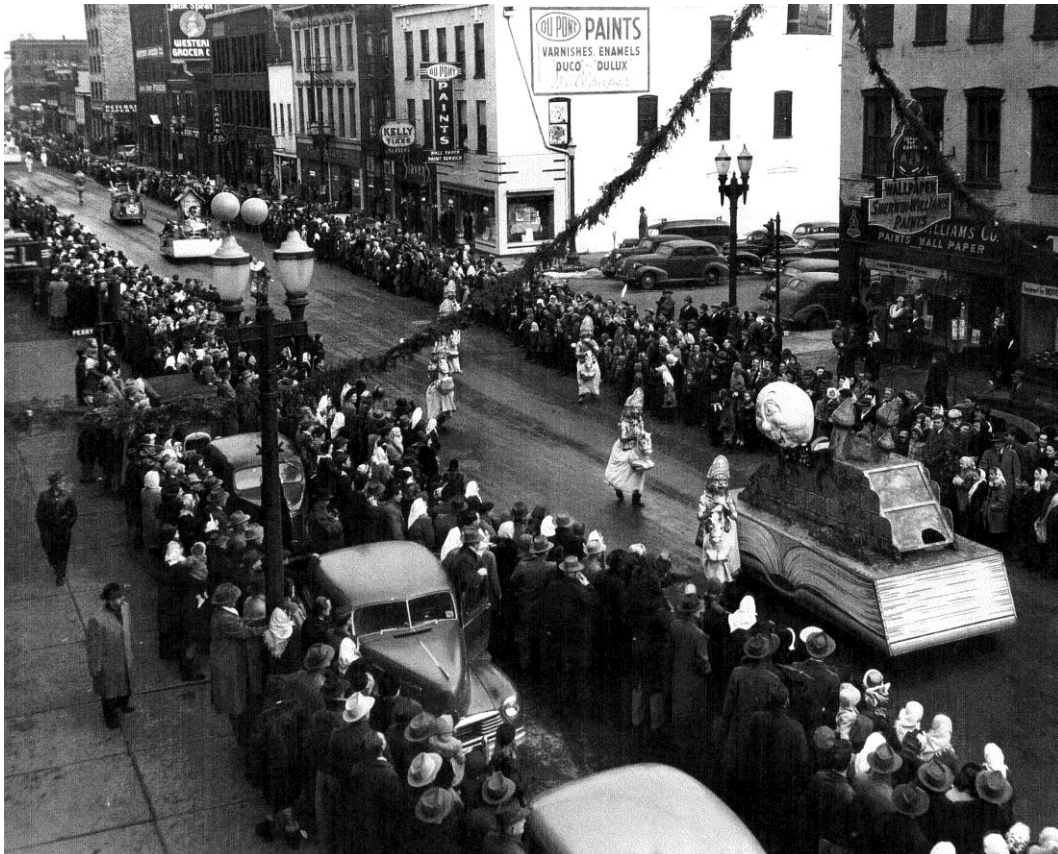
This 1940s view of East Second Street, looking southeast from between Brady and Perry Streets, documents the Knostman building within the context of its mid-century streetscape.

As illustrated in a historic image, the original cornice of this building was lost along the way. Nothing has been constructed to replace the original.
