Iowa Department of Cultural Affairs
State Historical Society of Iowa
Iowa Site Inventory Form
Continuation Sheet

Site Number __ 82-00238 _____
Related District Number _____

Name of Property _____ Iowa Reform Building _____ County _____ Scott _____

Address _____ 526 W. 2nd Street _____ City _____ Davenport _____

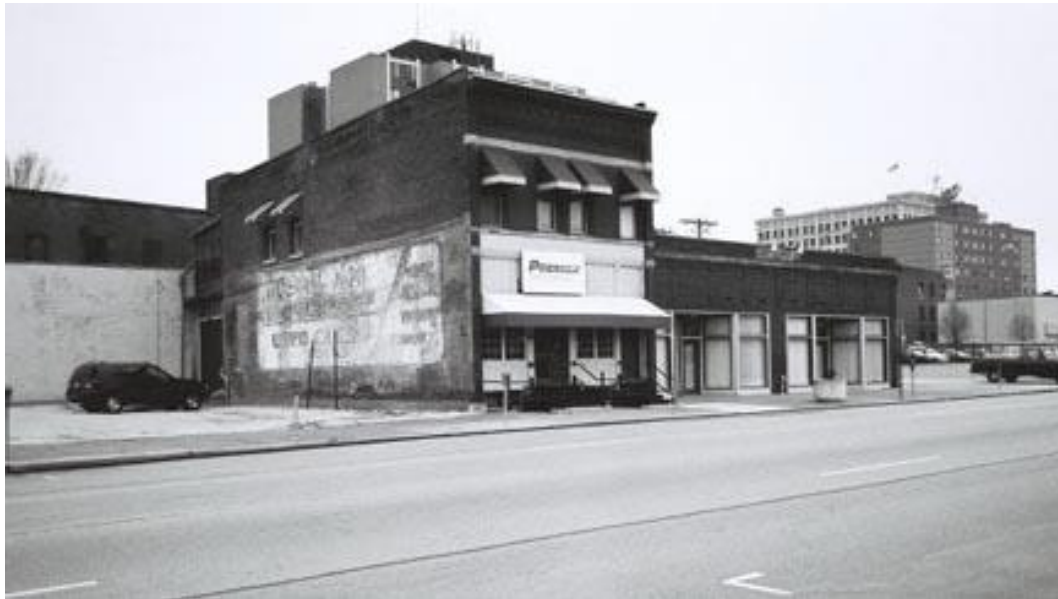
This view of West Second Street, looking northeast shows the tremendous loss of historic fabric in this block of the Davenport Downtown Commercial District.

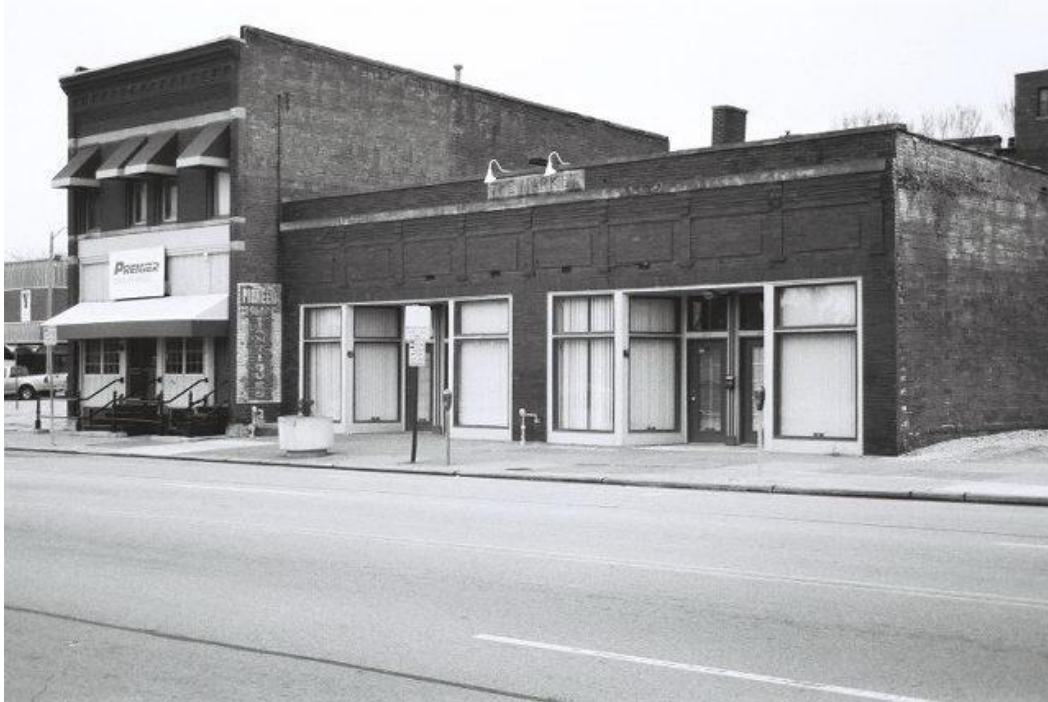
View of the Iowa Reform building (at left); south elevation, looking northwest across West Second Street.

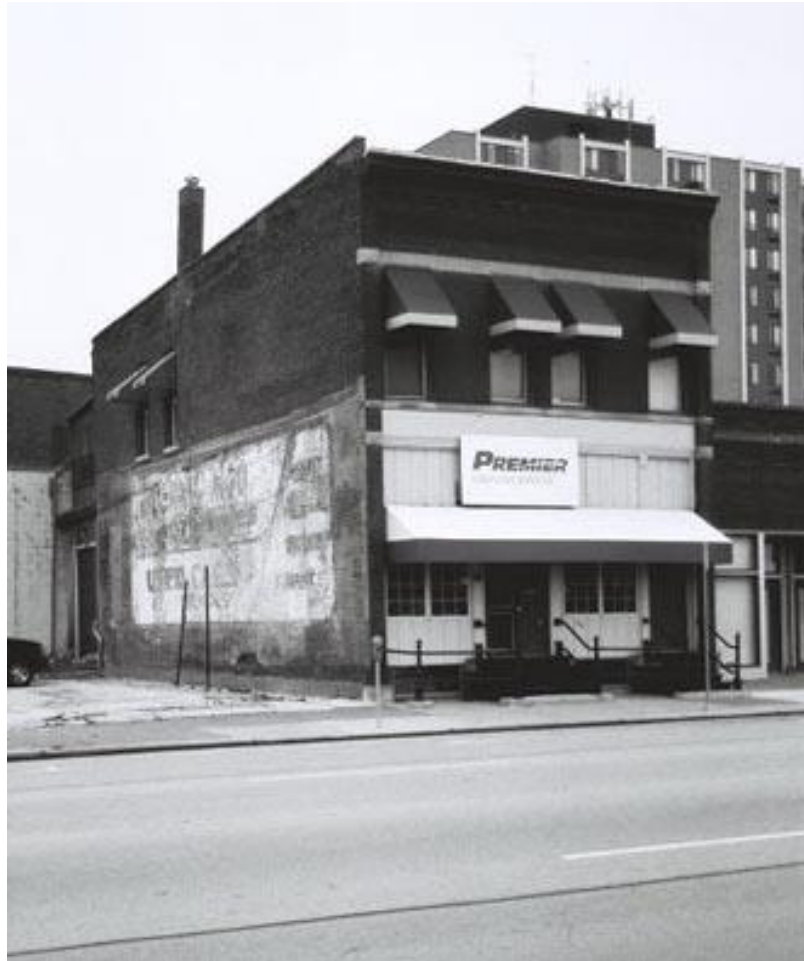
As a masonry structure, the greatest concern for this building is the condition of its brick. Generally speaking, the building can be described as suffering some measure of joint loss throughout. The west elevation (now fully exposed due to loss of an adjoining structure) shows significant deterioration of joints and brick spall along the parapet wall and near the foundation. In addition to this deterioration, the upper wall has been patch repaired and a window near the rear of the elevation has been bricked in.

View of the primary (south) and west elevations, looking northeast across West Second Street.

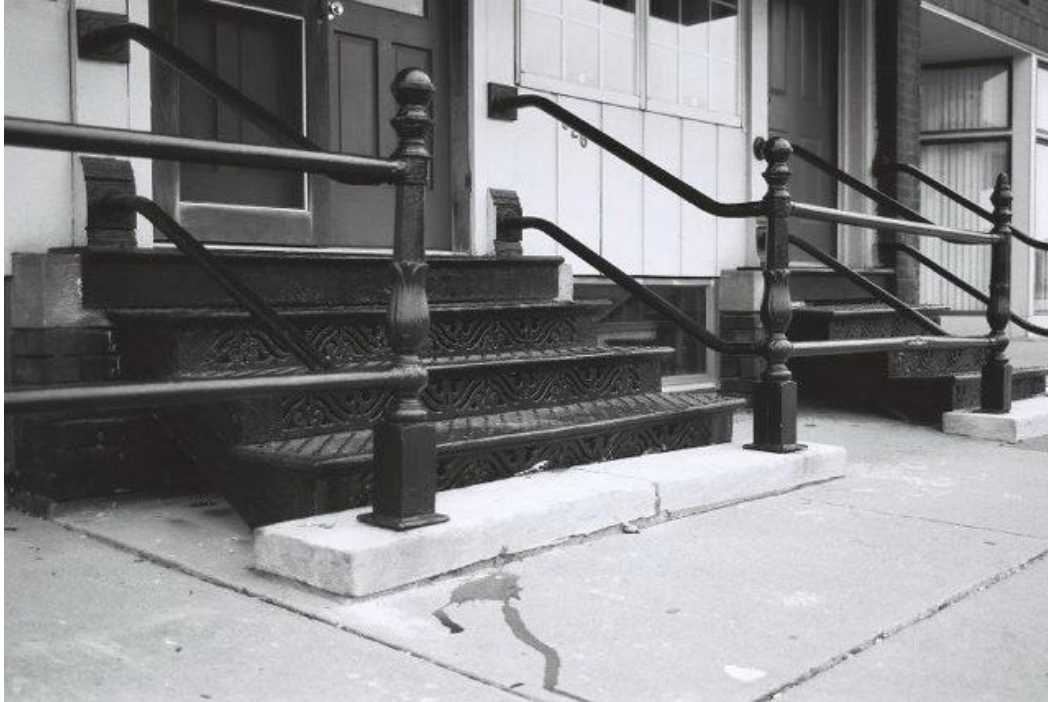
The building's storefront features dual entrances accessed by iron steps and handrails. Cast iron is also used in the columns of the storefront (now painted). The iron elements are most certainly original to the structure. In all likelihood, a 1998 rehabilitation, (Scott County Assessor), was responsible for the storefront's current incarnation which features vertical wood boards, multi-paned windows, and a large, fixed awning. Despite these invasive changes, original entrances remain intact, helping to retain an important level of historic integrity.

Detail view of the cast iron steps and railings.

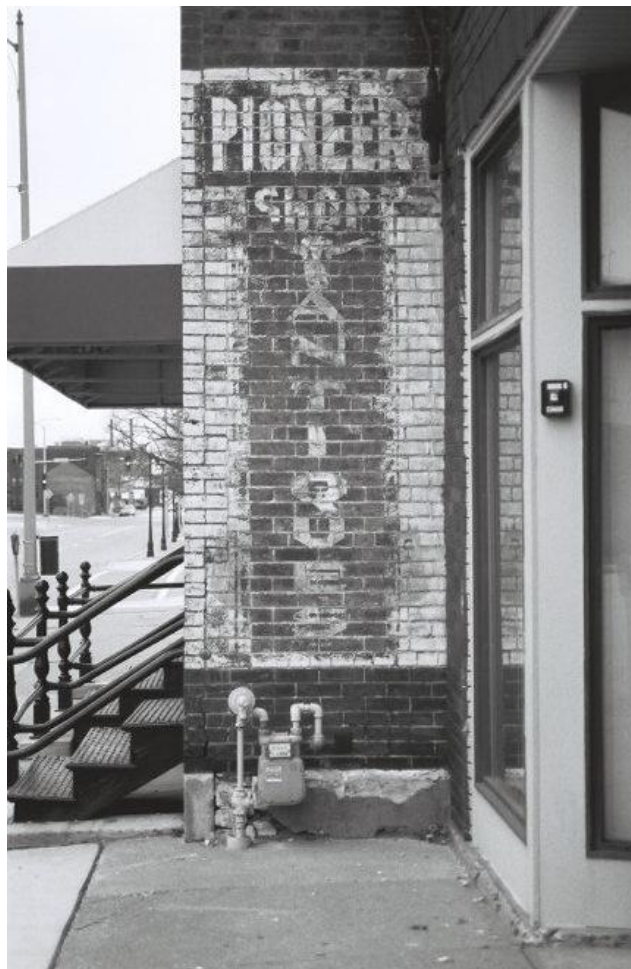
Like the west elevation, the exposed areas of the east wall have areas of significant deterioration. Deterioration on the primary (south) elevation appears to be confined to joint loss on the piers, significant due to their structural function.

This signage remnant is located on the east wall of the building. It reads “Pioneer Shop Antiques”.

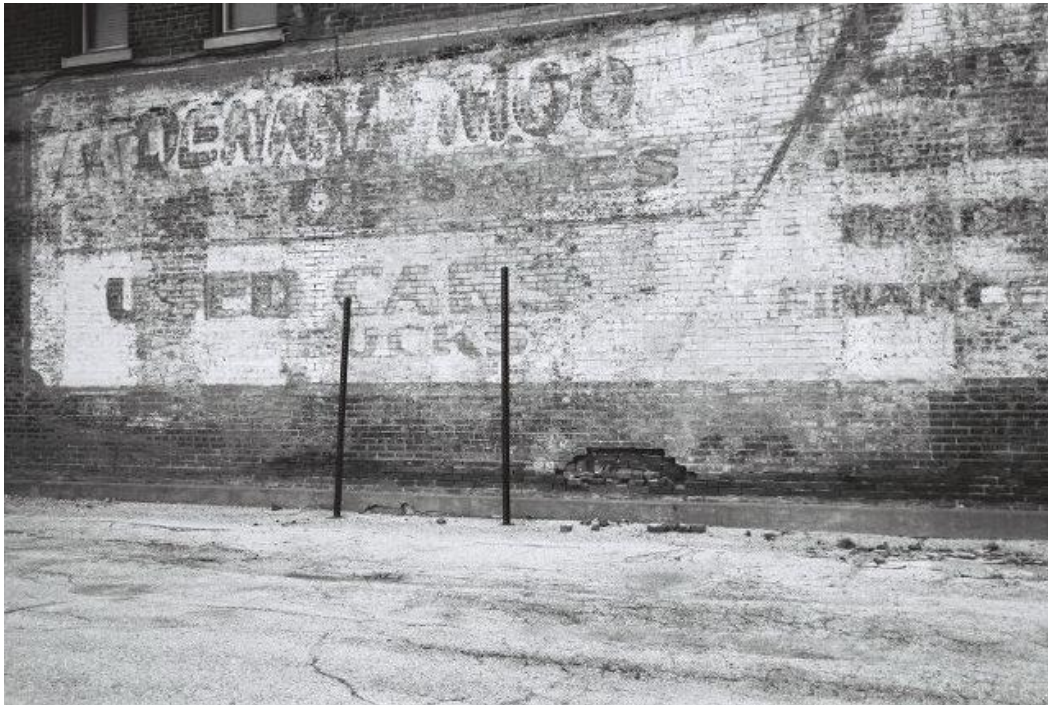
Detail view of the west elevation. The faded signage appears to read “Denny Moo Used Cars & Trucks”.
